## DeLorean Owners Association Regional Chapter 41

## Tech Notes

### Disassembly Continued

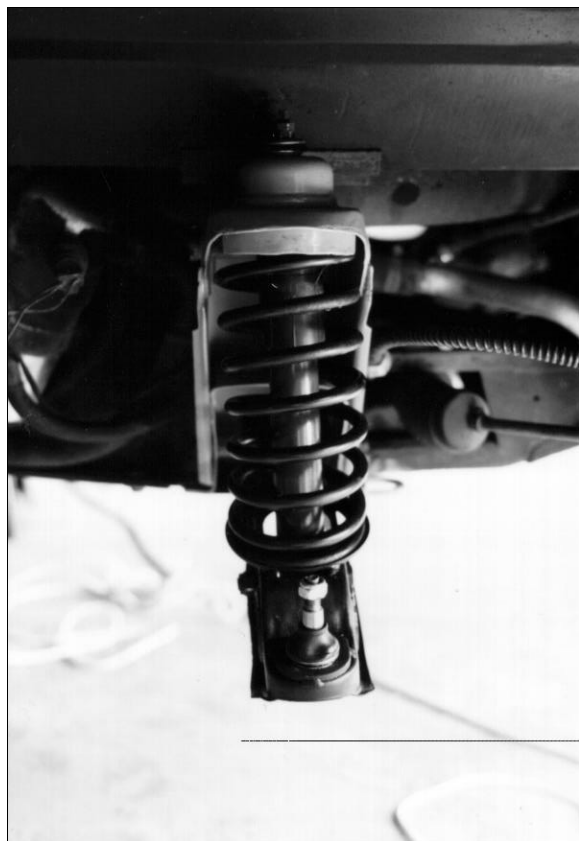
After the procedure outlined in the previous issue, the suspension should appear as in the photo below – only the lower control arm and spring remain of the front suspension assemblies (note that the swaybar has also been removed – see errata at right).

Partially disassembled front suspension.

The next step involves compressing the coil spring with a spring compressor in preparation for removing it. Do not remove the shock absorber until the spring is sufficiently compressed to release the tension from the lower control arm. Doing so will allow the spring to

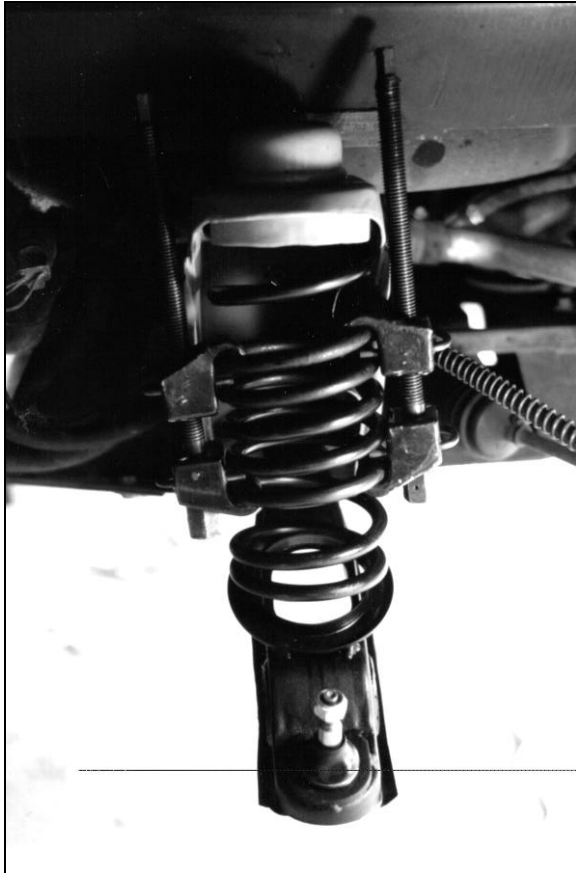
Once the spring is adequately compressed and the compressors are secure, remove the shock absorber. Your front suspension should look as in the figure below.

Compressed spring ready for removal.

Remove the compressed spring (take special care when handling compressed springs) and the rubber seat (46) on which it rests at the top of the suspension tower. If you are having your springs modified, slowly decompress the spring in order to remove the spring compressors.

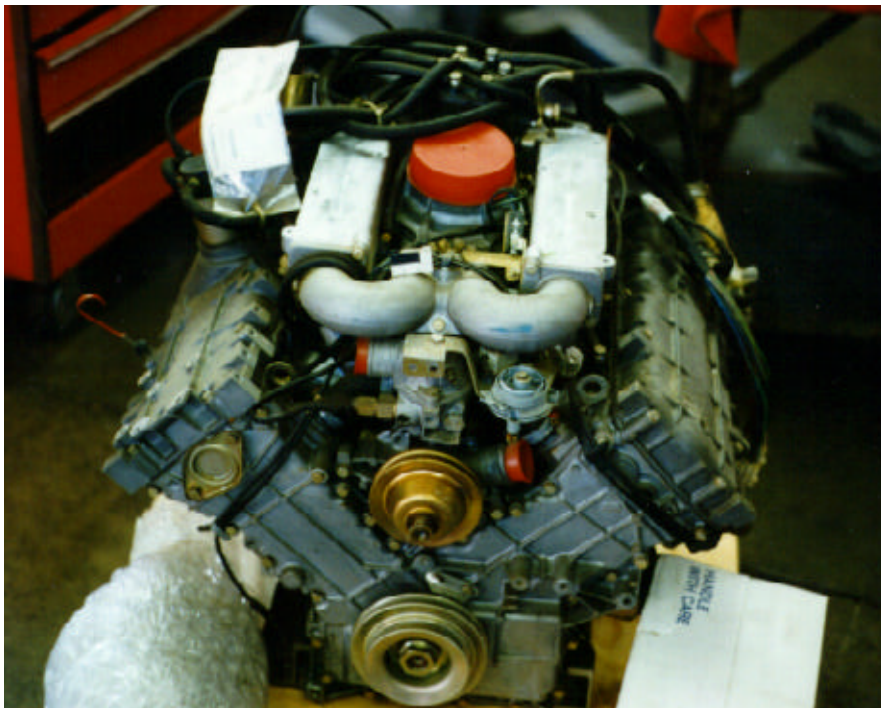
Below is a photo of the new engine I had installed in my DeLorean. The configuration as shipped includes everything except for the air cleaner. The A/C compressor and alternator were removed for shipping. As there are no more Motorola alternators to be had, the shipped engine is configured with the Ducellier alternator. I purchased the engine for about \$4000 through Specialty Automotive, and Foreign Car Specialists estimates installation could be done for about \$1500. If you are interested, call Chris at FCS (357-7049) for information.
